Manhole Inspection Summary

Manhole # S53Q__016MH

Insp Date: **11/5/08 12:58 PM**

Location Address: **s. ellwood ave**

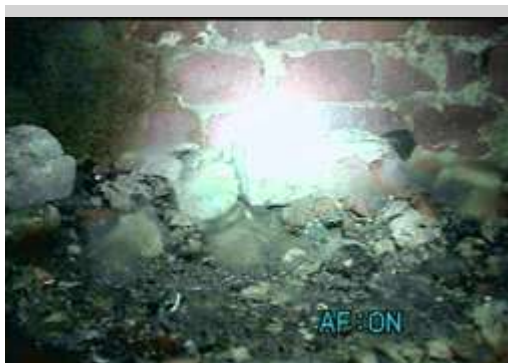
Defect 3

Condition: ☐ Sound ☐ Cracked ☐ Root Intrusion ☐ Deteriorated ☐ Leaks ☒ **Debris**

bench debris

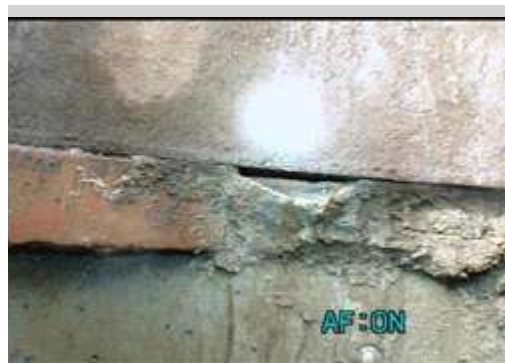
Defect 2

Condition: ☐ Sound ☒ **Cracked** ☐ Root Intrusion ☐ Loose Brick ☐ Deteriorated

Infiltration: ☐ None ☐ Joint ☐ Cracks ☐ Mortar ☐ Roots ☒ **Wall**

frame adj

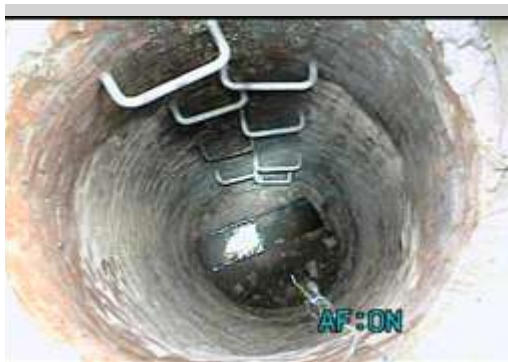
Defect 1

Steps Count: **9** Missing: **0** ☒ **Corroded**

cor.steps
